Report 03045

Report on weather conditions related to an aircraft accident 6 March 2001

Report prepared for Aircraft Accident Investigation Board

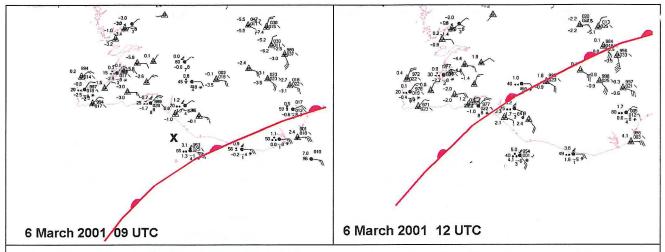
On Fig 3 the approximate position of the surface front is shown together with synoptic observations from stations in SW-Iceland. Fig 4 shows a numerical forecast map of level mean sea pressure, 10 m wind, 2 m temperature and accumulated precipitation. The strong temperature gradient and warm advection associated with the front appears clearly.

Fig 3 - Surface observations and approximate position of the warm front over the south coast of Iceland 6 March 2001. Left: 9 UTC. The approximate position of the accident is marked with **x**. Right: 12 UTC

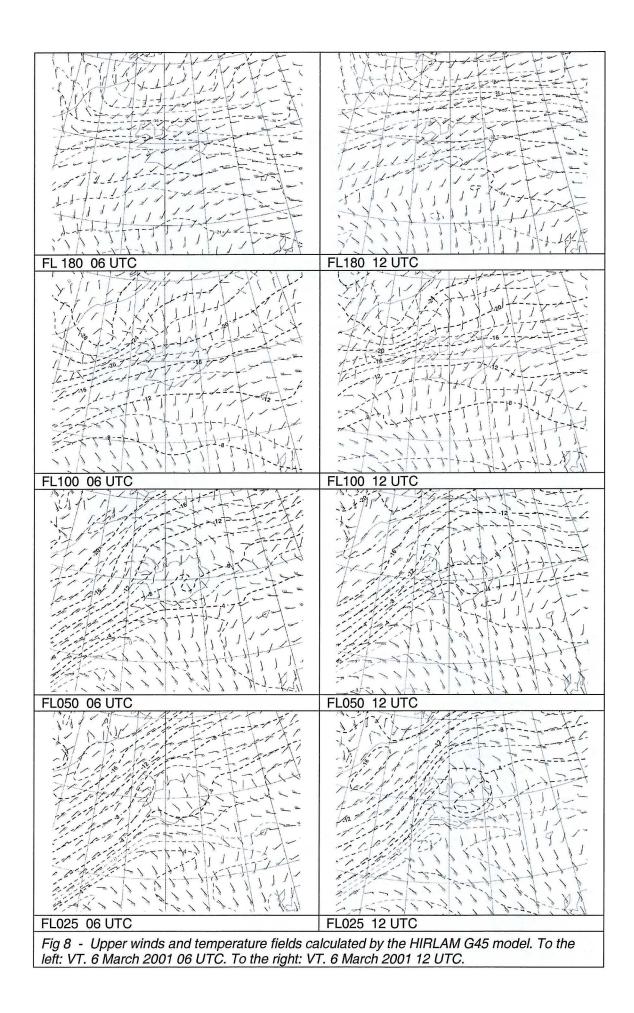
Upper winds and temperatures as calculated by the HIRLAM G45 numerical model may be seen on Fig 8. The model run is based on data from midnight (00 UTC) and 6 hours and 12 hours forecasts are shown. The sharp frontal zone off SW-Iceland is very marked in the lower levels (FL025 and FL050) and the warm advection seems to have extended at least up to FL180.

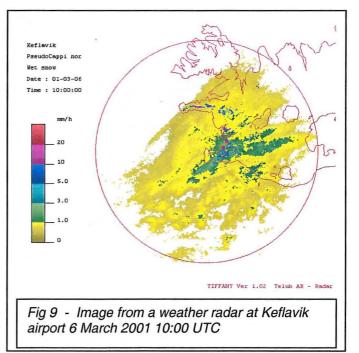
Radar images from the exact time of the accident are not available but simple pseudo-cappi images scanned between 10:00 UTC and 11:00 UTC can be shown. On the image from 10:00 (Fig 9) one can see that the precipitation in and ahead of the front was rather continuous and uniform. The main exception, apart from some local influence from the orography of Iceland, is a band of increased precipitation which was moving slowly towards NW and was approaching BIKF by 10:00 UTC. The possible nature of this precipitation band will be discussed later.

On Fig 9 one can see how the precipitation was detected by the weather radar near Keflavik Airport at 10:00 UTC. The precipitation seems to have been rather uniform but a band with higher intensity was approaching the radar site from the southeast. There is also an indication of more intense precipitation over the southwest coast, not far from the site of the accident.

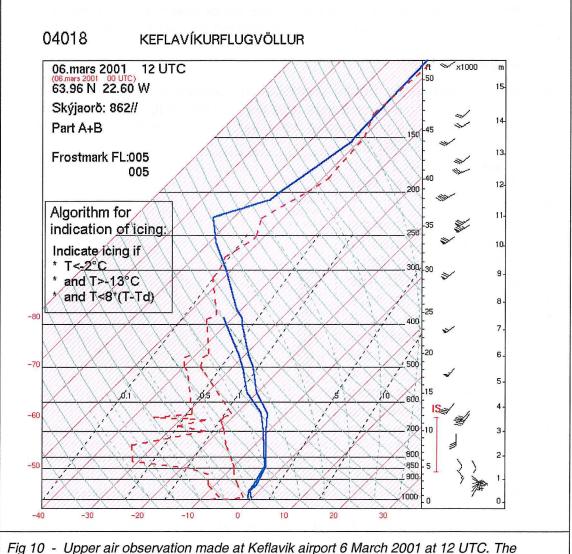
the form of the precipitation was reported as snow. From the upper air observation at Keflavik Airport at 12 UTC (Fig 10) one can see that the temperature was just below zero in a 4000 feet thick layer. It is not impossible

but still not very likely and can not be confirmed that some precipitation has fallen as freezing rain somewhere near the airport in the approximately 3000 feet thick layer beneath the frontal surface. If that is the case there is a slight possibility that the plane encountered icing in form of freezing rain, eventually mixed with snow, during take-off or the first phase of the climb.

From upper air observations (Fig 10) and surface maps it can be estimated that the slope of the frontal surface was of the order of 1:150. By the time of departure the frontal surface would then have been in an altitude of approximately 3000 feet over BIKF, descending towards the SE. The plane has therefore penetrated the frontal surface already after less than 10 minutes flight and after that it has been climbing in the relatively warm and moist air ascending over and behind the front. Under such conditions it is likely that a solid cloud cover will have built up and the upper air observation from 12 UTC (Fig 10) does not indicate any dry layers below 24000 feet. This means that considerable icing may be expected anywhere during the climb from the surface up to a considerable height.

On the diagram shown in Fig 10 the most typical layer for icing is indicated automatically by an algorithm based on temperature and moisture (difference between temperature and dewpoint). In this case the layer between 4000 and 12000 feet is indicated.

Above this layer one can see a layer with reduced static stability where the lapse rate is close to the wet-adiabatic. Within this layer, which goes up to 16000 feet, one could expect the formation of enhanced precipitation bands associated with instability rolls embedded in the massive warm front cloud. Fig

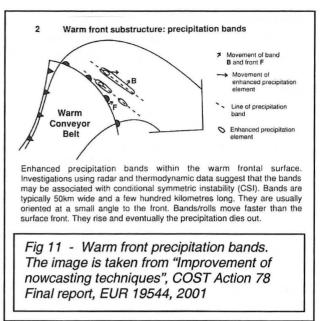
11 shows the likely position of such rolls relative to the warm front and the warm conveyor belt ascending along the frontal surface.

It has been suggested that within such lines of convection the vertical motion may be five or even ten times stronger than generally within the frontal system. These convection lines are good candidates for spots where one could expect icing much more severe than in other parts of the frontal cloud.
