Kristján Ágústsson  
Tómas Jóhannesson  
Siegfried Sauermoser  
Hörður Þór Sigurðsson

## Hazard zoning for Patreksfjörður, Vesturbyggð

This report is an assessment of avalanche hazard for the village Patreksfjörður which is within the community of Vesturbyggð. It was carried out by the Icelandic Meteorological Office (IMO). The assessment is done according to a regulation on hazard zoning due to avalanches and landslides, classifications and utilization of hazard zones, and preparation of provisional hazard zoning issued by the Ministry for the Environment in July 2000.

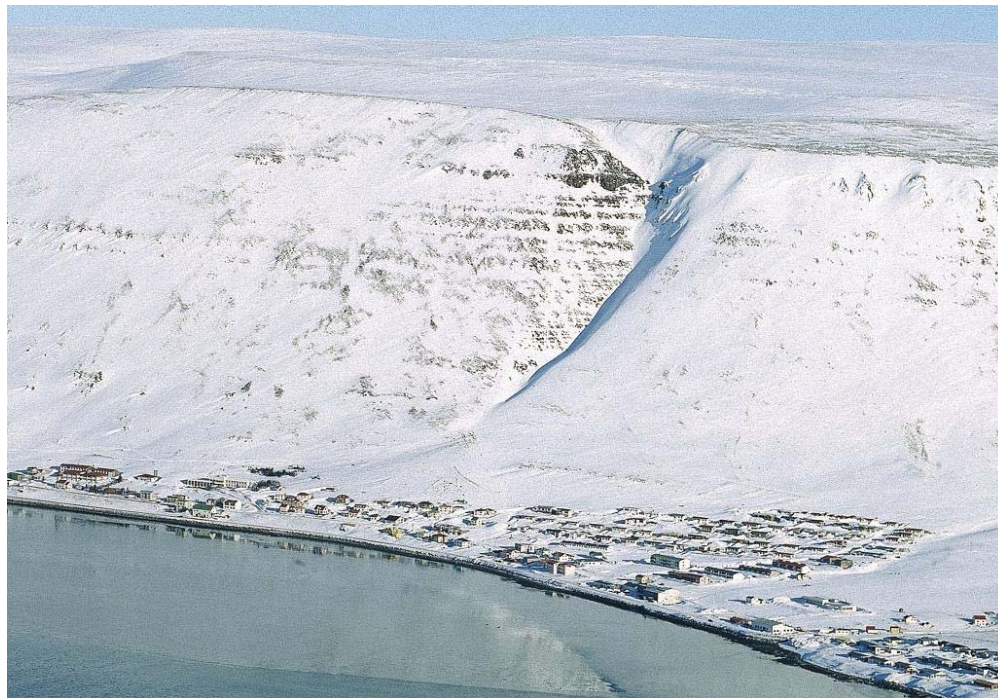
**Figure 5.** *Geirseyrargil og Sigtúnssvæði (Photo: © Mats Wibe Lund).*
