## Hazard zoning for Eskifjörður

This report describes the results of a project carried out by the Icelandic Meteorological Office (IMO) with the aim to evaluate avalanche, debris flow and rockfall hazard in Eskifjörður. The result is a hazard zoning proposal for Eskifjörður based on the current Icelandic hazard zoning regulation.

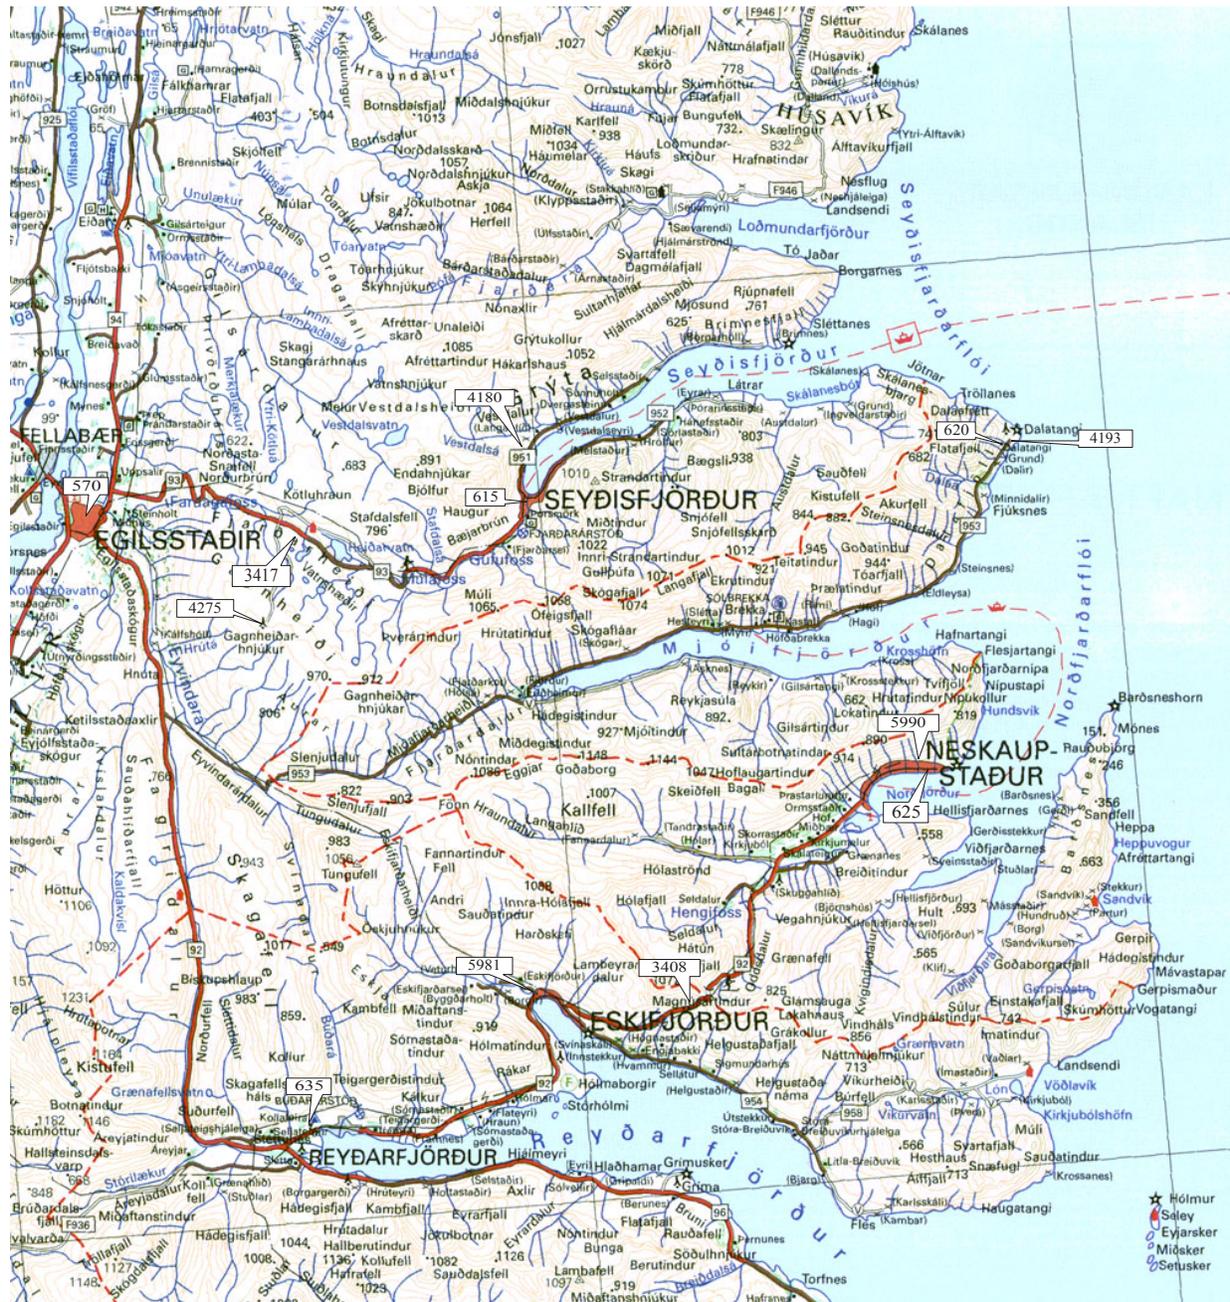
**Figure 1.** An overview of the area around Eskifjörður with the locations of meteorological stations indicated. © The National Land Survey of Iceland.

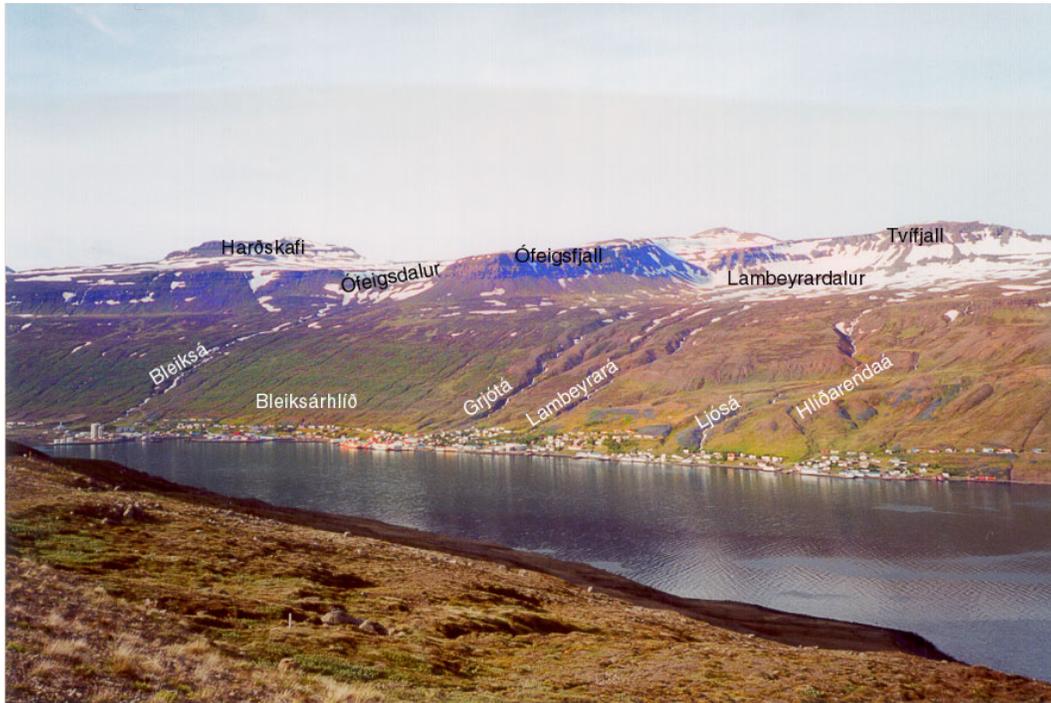
**Figure 2.** *Eskifjörður and the names of main landmarks. (Photo: Esther H. Jensen).*

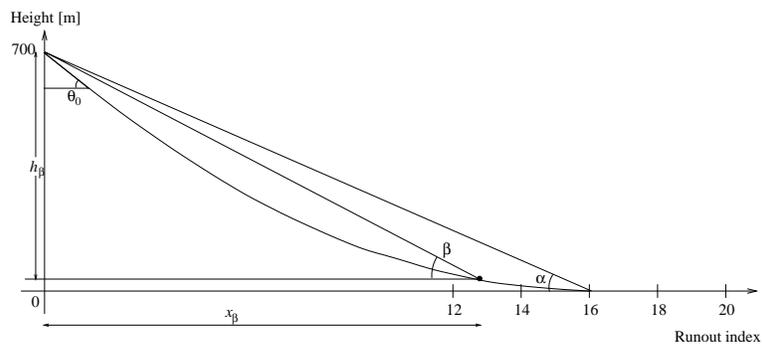
**Figure 3.** *The standard path. The  $\alpha$ -angle is the expected runout angle of an avalanche according to the  $\alpha/\beta$ -model.*

**Runout index:** The runout measured in hectometers of an avalanche that has been *transferred* (Sven Sigurðsson *et al.*, 1997) to the *standard path* making use of some transfer method. The runout index in this report is obtained by using the PCM-model with parameters lying on a predefined parameter axis. An avalanche that has a runout index of  $r_0$  is referred to as an avalanche with  $r = r_0$ . The method was developed by Kristján Jónasson *et al.* (1999).

**$F_{r_0}(F_{13})$ :** The expected frequency of avalanches with a runout index greater or equal than  $r_0$ . The value  $F_{13}$  is most often used, *i.e.* the frequency at the runout index  $r_0 = 13$ .
