Þorsteinn Arnalds  
Siegfried Sauermoser  
Tómas Jóhannesson  
Harpa Grímsdóttir

## Hazard zoning for Ísafjörður and Hnífsdalur Technical report

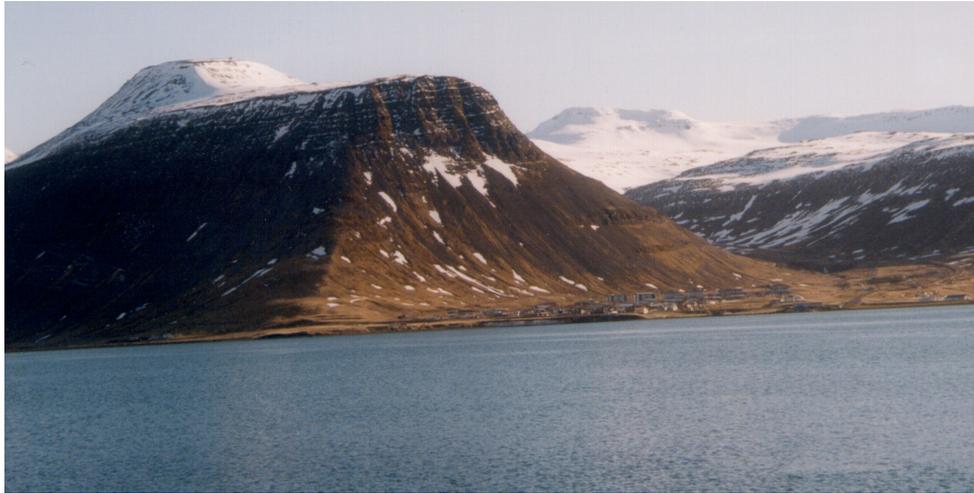
**Figure 4.** *Kubbi and Holtahverfi (Photo: Harpa Grímsdóttir).*

Figure 4 shows the area. It can also be seen on Maps 1 and 8 and longitudinal sections are shown in Drawings 16–19.

The roughly 2–3 ha starting area below the cliffs indicates that the potential size of an avalanche is limited. The shape of the starting zone in the eastern part of the hill and the avalanche chronicle both indicate that the risk is higher in the eastern part of the runout area than the western part. According to the chronicle, the 1984 avalanche had a deposit width of 75 m and a thickness of 2.5 m. A rough estimation of the deposit gives an avalanche volume of approximately 8,000 m<sup>3</sup>. Given the 0.8 m high fracture line, a fracture area of 1.0 ha is probable. The snow densities in the starting area and the deposit are unknown. The impact pressure of the 1984 avalanche is also unknown, but the damage to the houses suggests that it was not high.

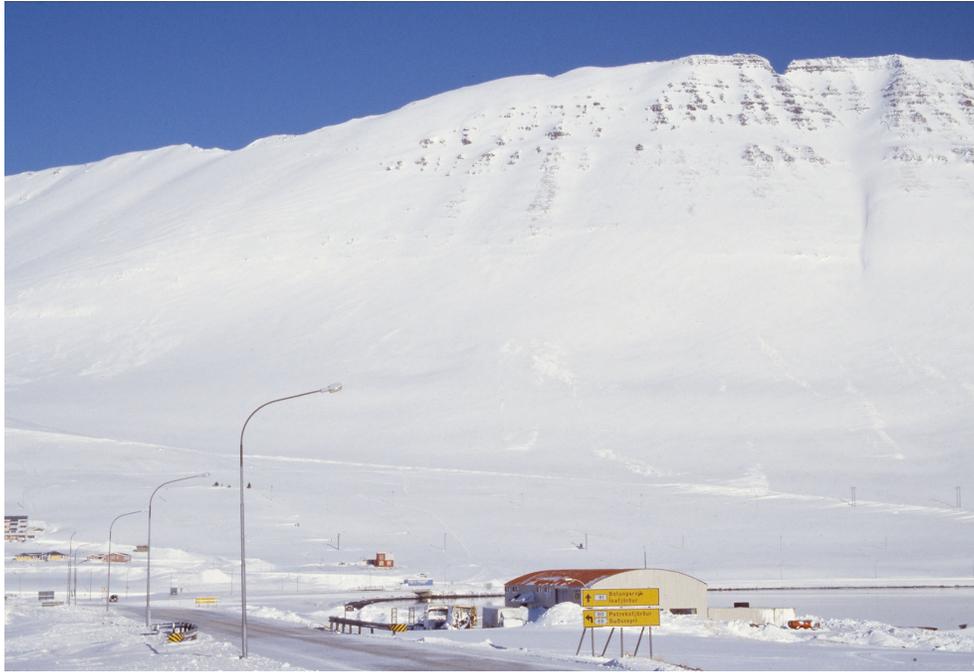
**Figure 5.** *Seljalandshlíð and the outer part of Seljalandshverfi (Photo: Jón Gunnar Egilsson).*

Figure 5 shows the area. It can also be seen on Maps 1 and 9 and longitudinal sections are shown in Drawings 1–4.

Due to the width and inclination of the starting area large avalanches are possible. As stated in the starting zone description, the starting area is 26.0 ha and therefore, avalanches of several hundred thousands m<sup>3</sup> are conceivable. The conditions favourable for snow accumulation are less frequent than further to the west because the prevailing northeasterly winds blow the snow from the starting area and accumulate it in the old skiing area and the slope above it. It is difficult to precisely quantify the relative frequency of large avalanches in this area compared to the skiing area, but they might be on the order of ten times less frequent. The location of the Seljalandsmúli ridge in the track may be expected to affect the flow of avalanches. The runup on the ridge is not high so the main effect of the ridge is caused by the lateral deflection. It directs avalanches more to the east in the direction of the Seljaland farm. The risk in the western part is then reduced, but correspondingly, the risk in the eastern part is increased. The existence of the Seljaland farmhouse in this more hazardous place does not invalidate this analysis. It does, however, lend support to the conclusion that large avalanches are rare. The avalanche track is gentle and the inclination does not change suddenly between the track and the runout area. This allows long runout distances for large avalanches. An avalanche can be expected to flow over the Seljalandsmúli ridge, but a shorter runout may be expected than in the western part of the area.

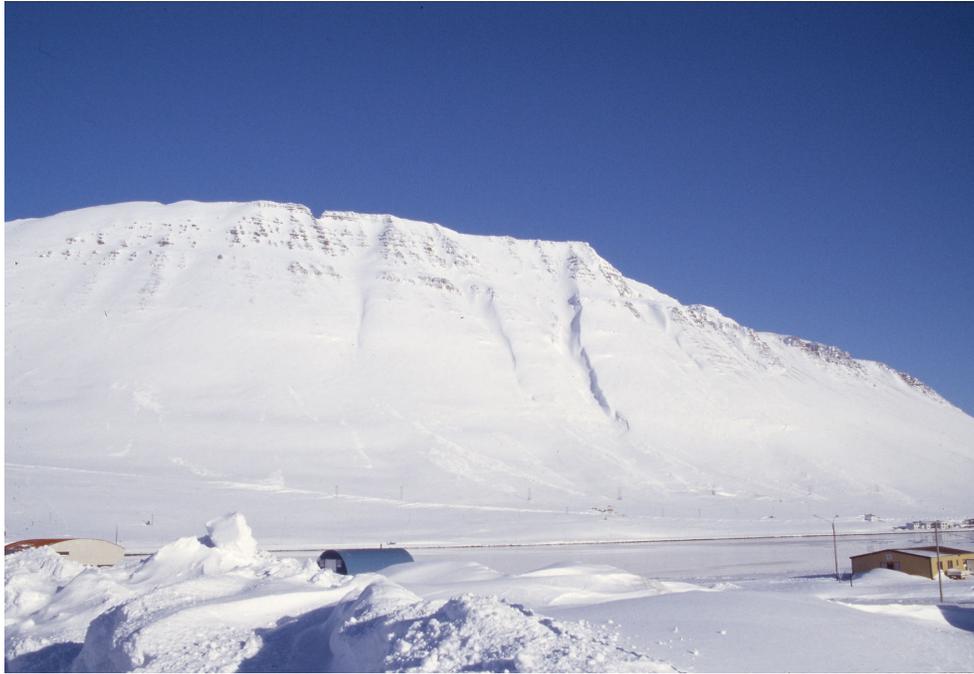
**Figure 6.** *Seljalandshlíð between Seljaland and Gleiðarhjalli (Photo: Jón Gunnar Egilsson).*

Figure 6 shows the area. It can also be seen on Maps 1 and 9 and longitudinal sections are shown in Drawings 5–8.

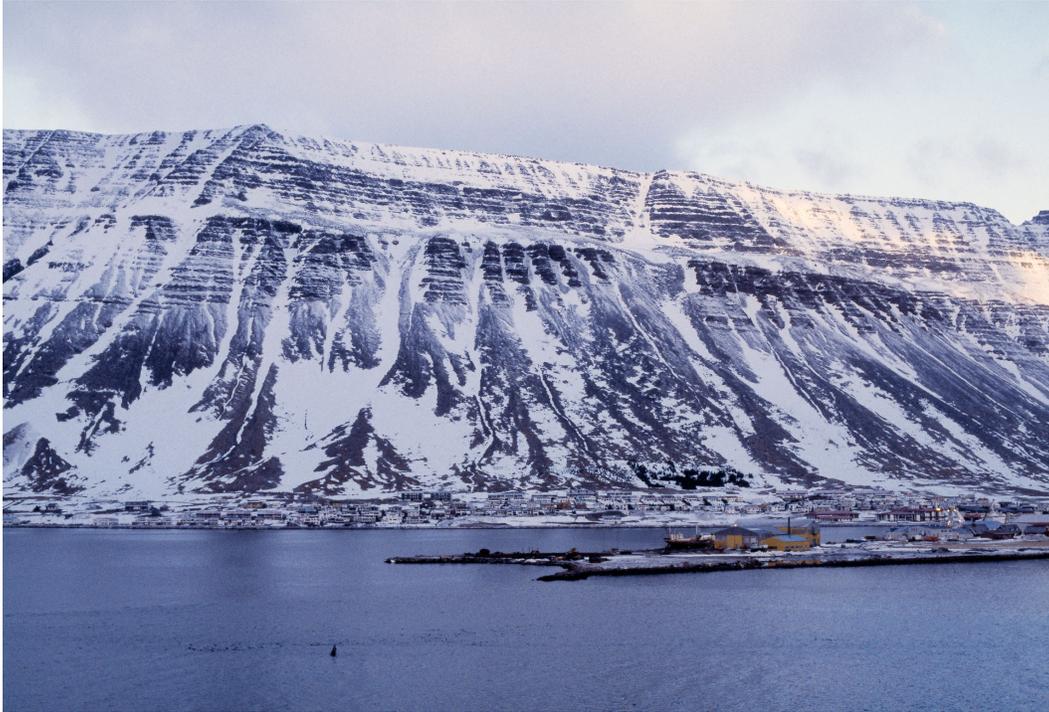
**Figure 7.** *Eyrarfjall and Gleiðarhjalli (Photo: Jón Gunnar Egilsson).*

Figure 7 shows the area. It can also be seen on Maps 1 and 10 and longitudinal sections are shown in Drawings 9–15.

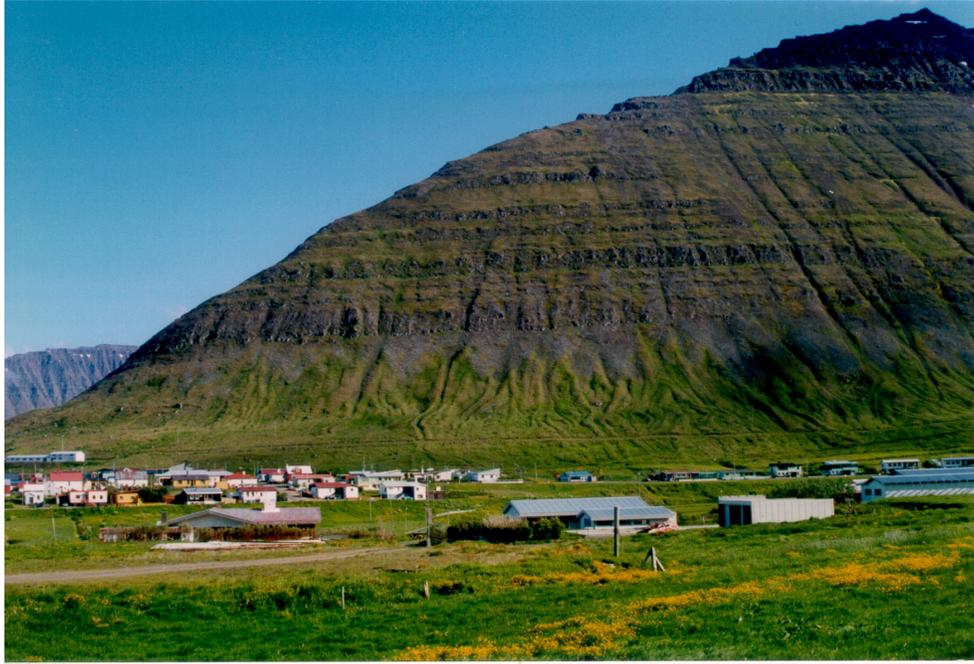
**Figure 8.** *Bakkahyrna* (Photo: Harpa Grímsdóttir).

Figure 8 shows the area. It can also be seen on Maps 1 and 11 and longitudinal sections are shown in Drawings 24 and 25.

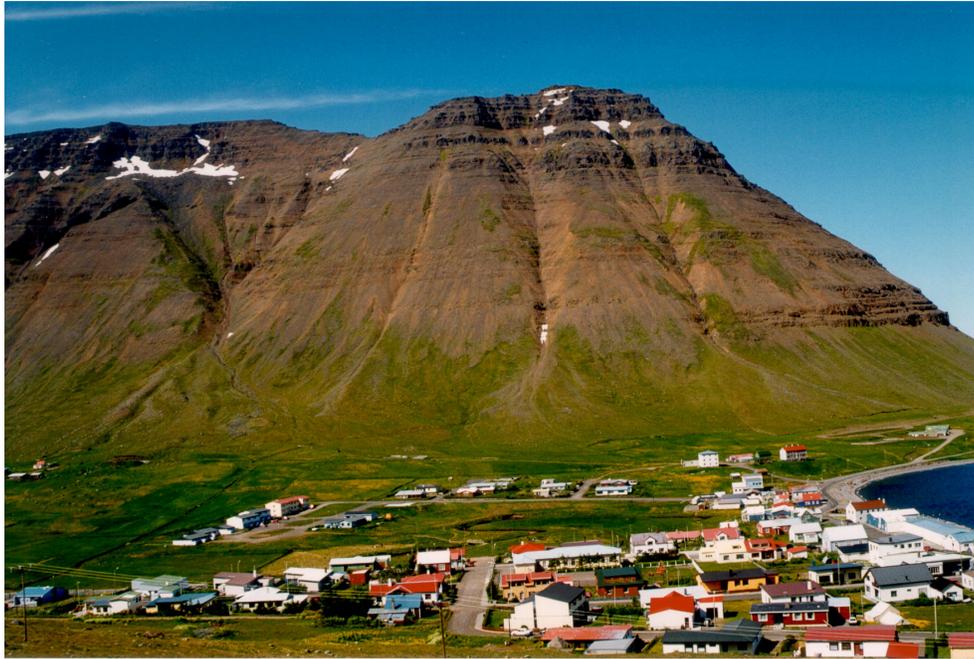
**Figure 9.** *Búðarhryna and the northern part of the settlement in Hnífsdalur (Photo: Harpa Grímsdóttir).*

Figure 9 shows the area. It can also be seen on Maps 1 and 11 and longitudinal sections are shown in Drawings 20–22.
