Esther H. Jensen
Thomas Sönser

Process Orientated Landslide Hazard Assessment for the South Side of Seyðisfjörður

VÍ-ÚR02
Reykjavík
January 2002

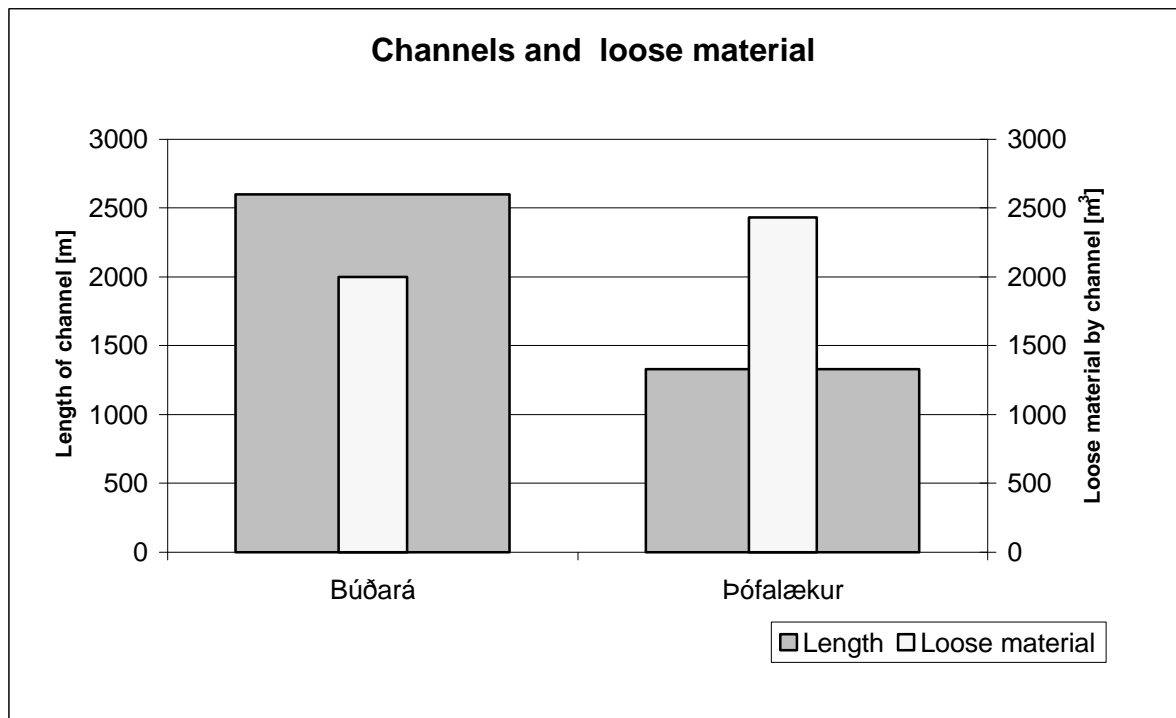
Figure 5.1 Channels and available loose material

The investigation area was too large to analyse all the channels in a consistent manner within the time limit of the project. It was, therefore, decided to find two typical catchment areas for the dominant types of watersheds. This fact has to be considered when judging the results. Consequently, the investigated catchments are not the only ones that endanger the settlement area. The catchment areas chosen for the most detailed study serve as examples of different types of hazard processes. The main difference between the selected catchments can be seen in Figure 5.1.

ments) (see Figure 5.1). By mapping the characteristics of the paths it is possible to draw conclusions about channel-events in the past, which in a further step allows, in combination with the geo- and hydro-inventory, to evaluate future events. The possible scenarios are valued by interpreting cross sections measured in different parts of the catchments. One of the main aims of a process-orientated work, when working with natural hazards is to assess the potential of the path and to derive ideas about the type of process that caused large events in the nearest past.

After acquiring an overview of the area, a closer inspection was made at Þófalækur in order to check how events from the gully endanger the settlement area. One reason for taking a closer look at this area was evidence of an event in the past, that migrated sideways over the creeping area and into the path of Hæðarlækur. Consequently, the event was able to pick up more sediment than available in its usual path and bring it down to the settlement area. In contrast to Búðará, Þófalækur has a very small catchment area (see Figure 5.1).

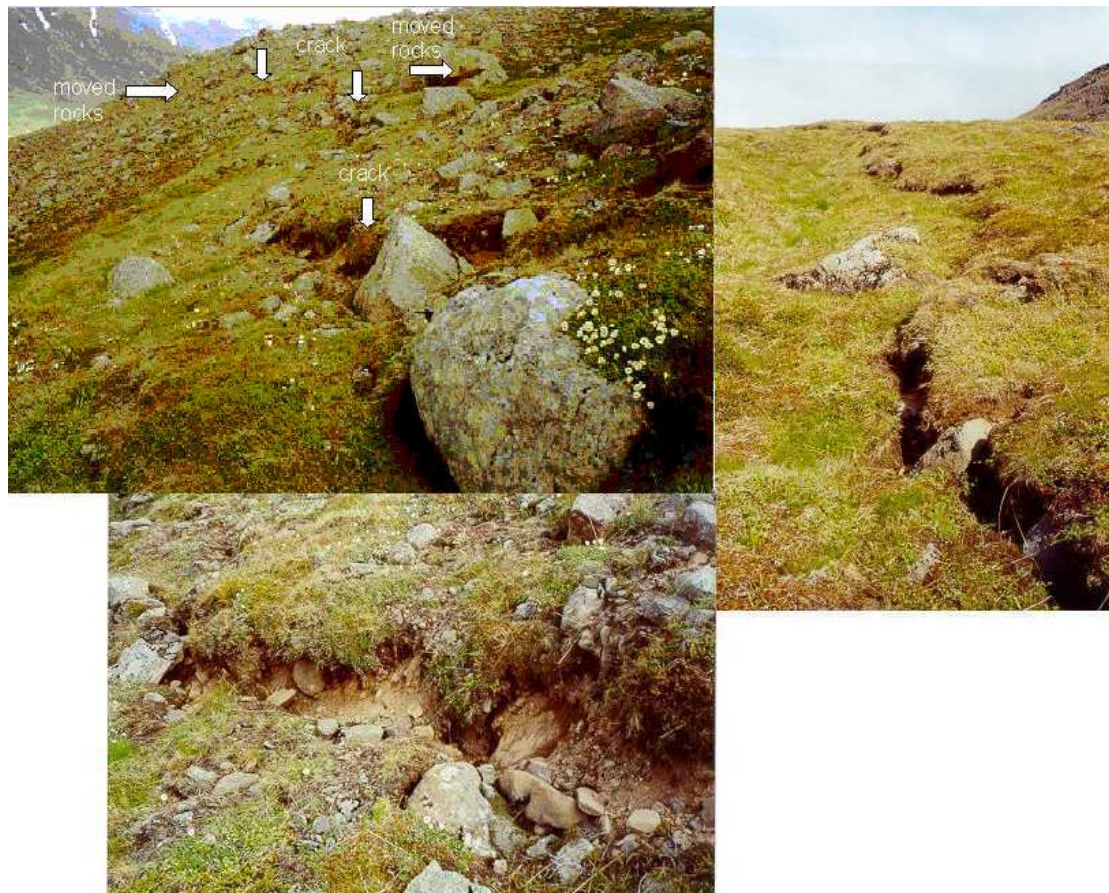
Figure 5.2 Evidence of creep in Þófi

Indications of mass movements in the area of Þófi were found in the overview based on the air-photo interpretation and in the investigation by Sæmundsson and Pétursson (1999). The field investigations showed evidence of shallow landslides in the glacial deposits without bedrock being involved in the movement. A mass creep and shallow slides were detected in till on the steep slope above the fish factory (see location of houses in Map 1, Appendix C). This movement is considered active because of fresh open gaps and obvious vertical displacements at the surface (see Figure 5.2).

There is also evidence of openings of the front slope in some parts near the middle of the slope that suggest an active creeping process (see Figure 5.2). During a heavy rainstorm in October 2001, when 153 mm of rain fell in one day, a 100 m long crack opened in the surface of the front slope of Þófi immediately north of Hæðarlækur. The movement did stop before a catastrophic failure of this part of the slope was initiated but small slides were released from the front slope further to the north. Fixed points were installed after the storm to detect future movement of the surface masses. Insignificant movement has been recorded since then and therefore the movement seems to be caused by increased pore pressures related to heavy precipitation (Jensen, 2001).
