Hazard zoning for Siglufjörður

Technical report

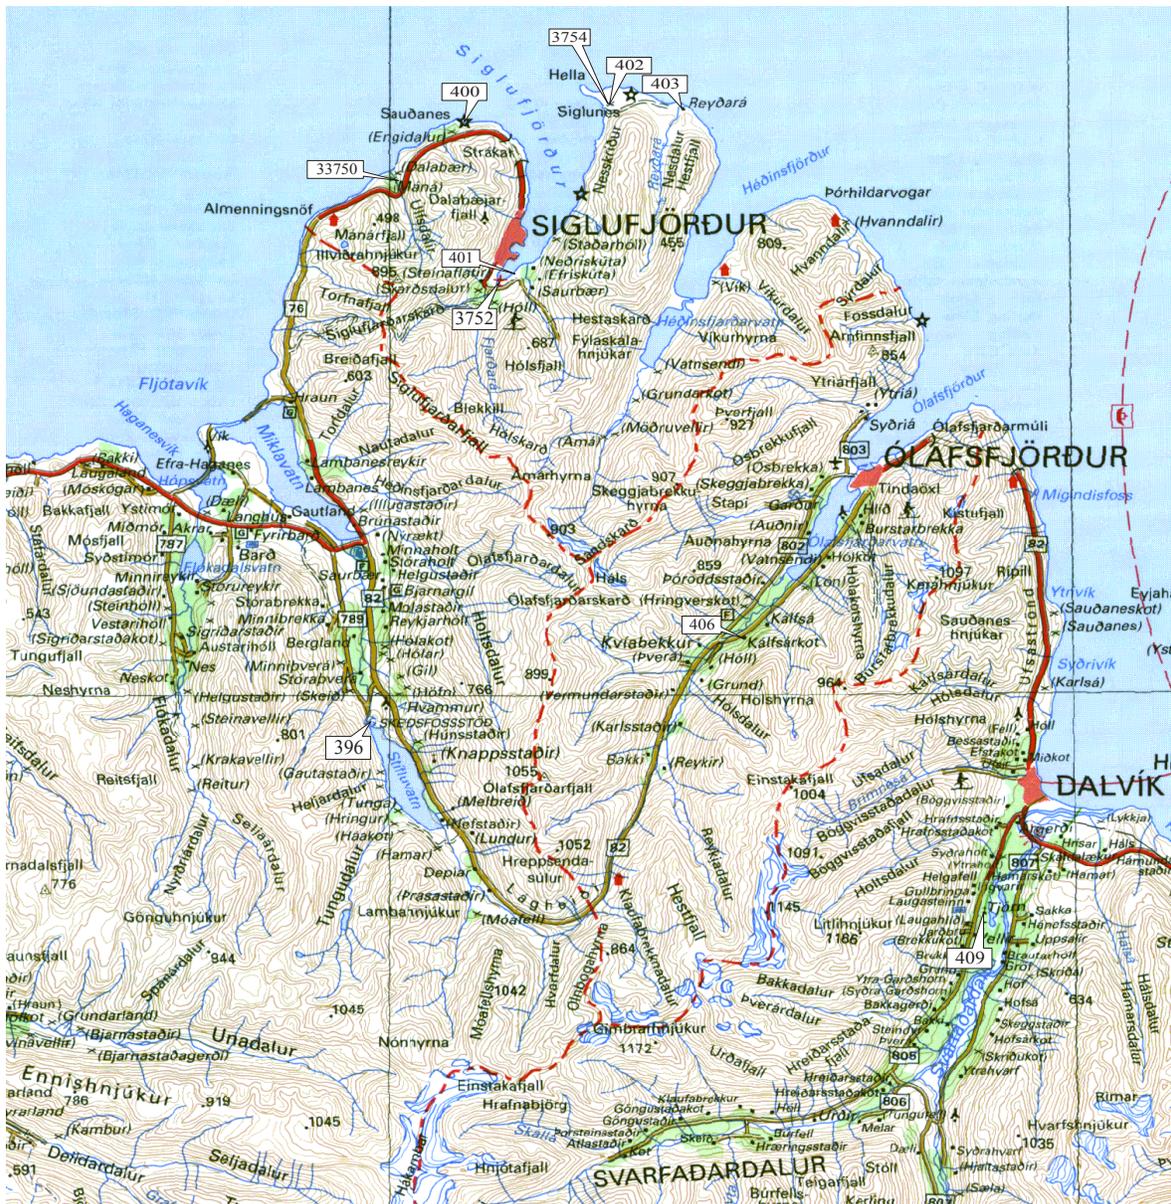
Figure 1. An overview of the area around Sigluffjörður with the locations of meteorological stations indicated. © The National Land Survey of Iceland.

observations at these two stations. Since 1995 automatic weather stations have been operated at Siglunes, Siglufjörður and by Siglufjarðarvegur (the road between Siglufjörður and Skagafjörður). Since 1990 synoptic observations have been carried out at Sauðanesviti, which is the only station in the area where present weather is observed. In addition several stations close to Siglufjörður record precipitation and snow depth. These are Skeiðsfoss in Fljót, Kálfsárkot in Ólafsfjörður and Tjörn in Svarfaðardalur. The manual observations of precipitation in Siglufjörður were replaced by an automatic precipitation recorder in 1995. The location of these stations is shown in Figure 1.

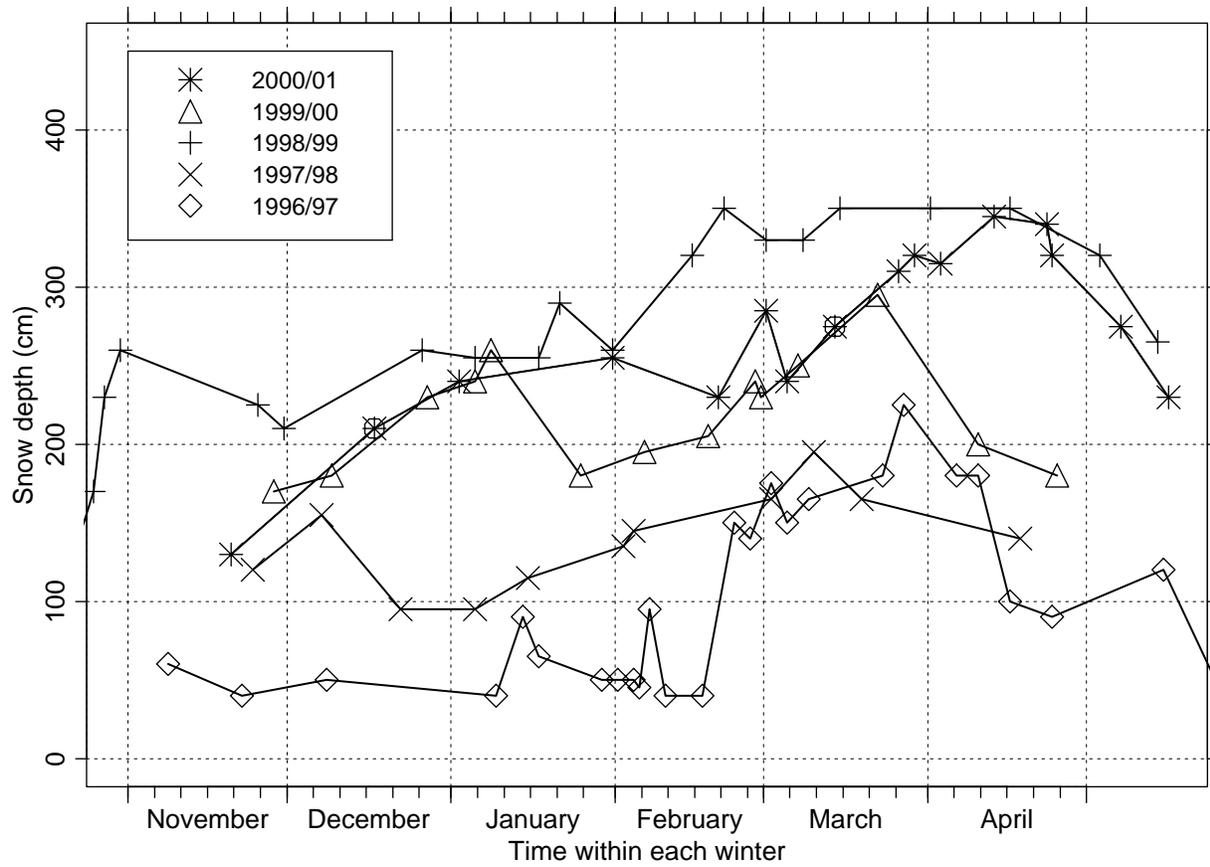
Figure 2. Snow depth at stake sig104 at 531 m a.s.l. above Fífladalir in Hafnarfjall.

Snow depth has been monitored regularly in the supporting structure test area in the gully Grindagil above Fífladalir since 1996. These measurements are summarised by Stefan Margreth (SLF, 2001) and tabulated in technical reports describing the results of the supporting structure experiment. They show that large amounts of snow accumulate in the gully, in some cases exceeding

8 m vertical snow depth. This indicates that snow depth in the main gullies above Siglufjörður can exceed the snow depths in the unconfined parts of the slope by a factor of 2–3 or even more. Field observations in the spring of 2001 showed locally very high snow depths (> 4 m) in several large cornices that are formed above 520 m a.s.l. near the top of Hafnarhyrna.

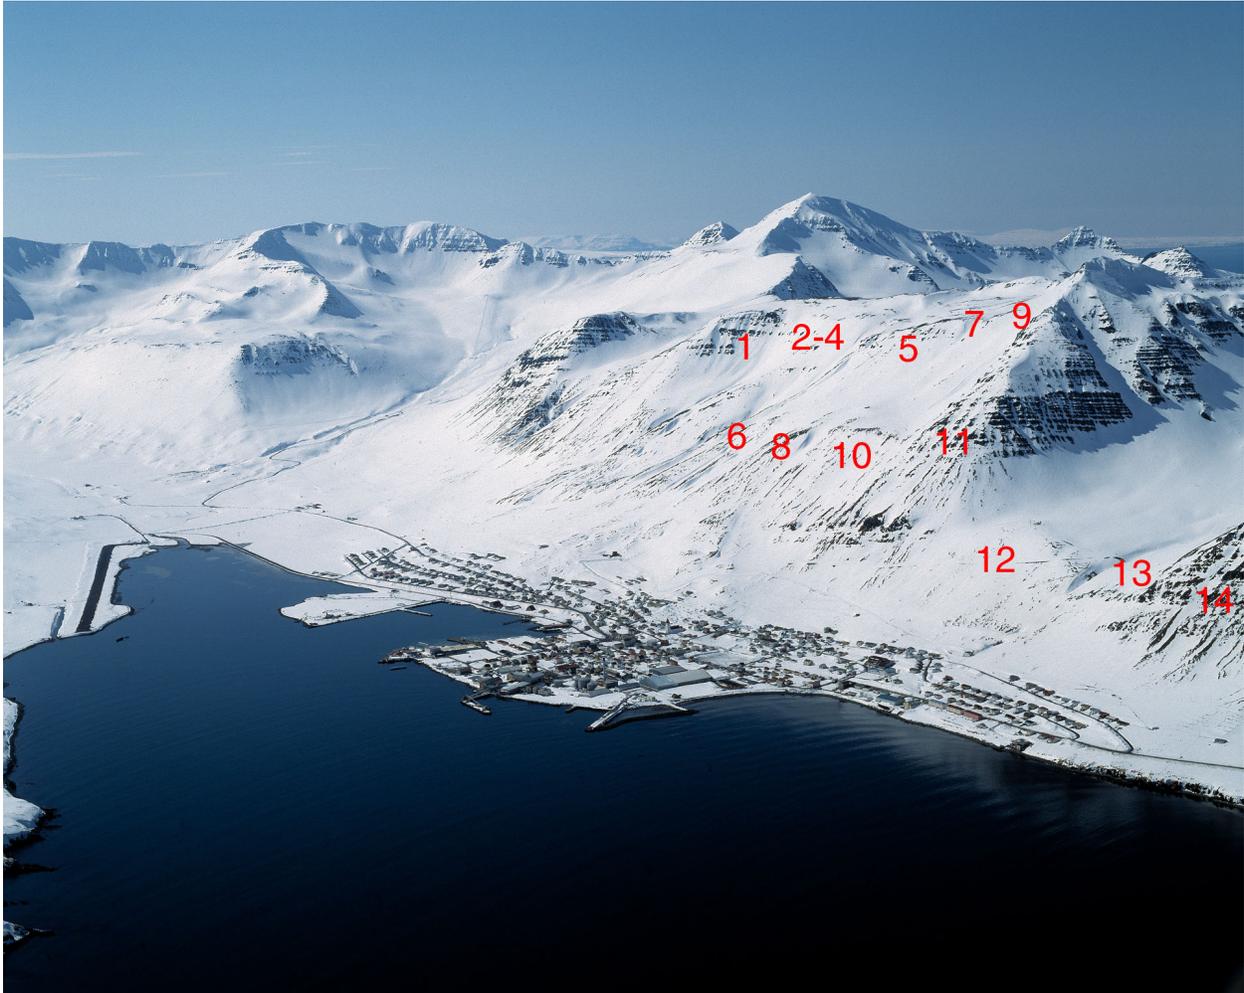
Figure 3. View from north east of the avalanche paths above Siglufjörður. The red numbers indicate the approximate location of starting areas that were delineated during field investigation (see Map 4) (Photo: Mats Wibe Lund).

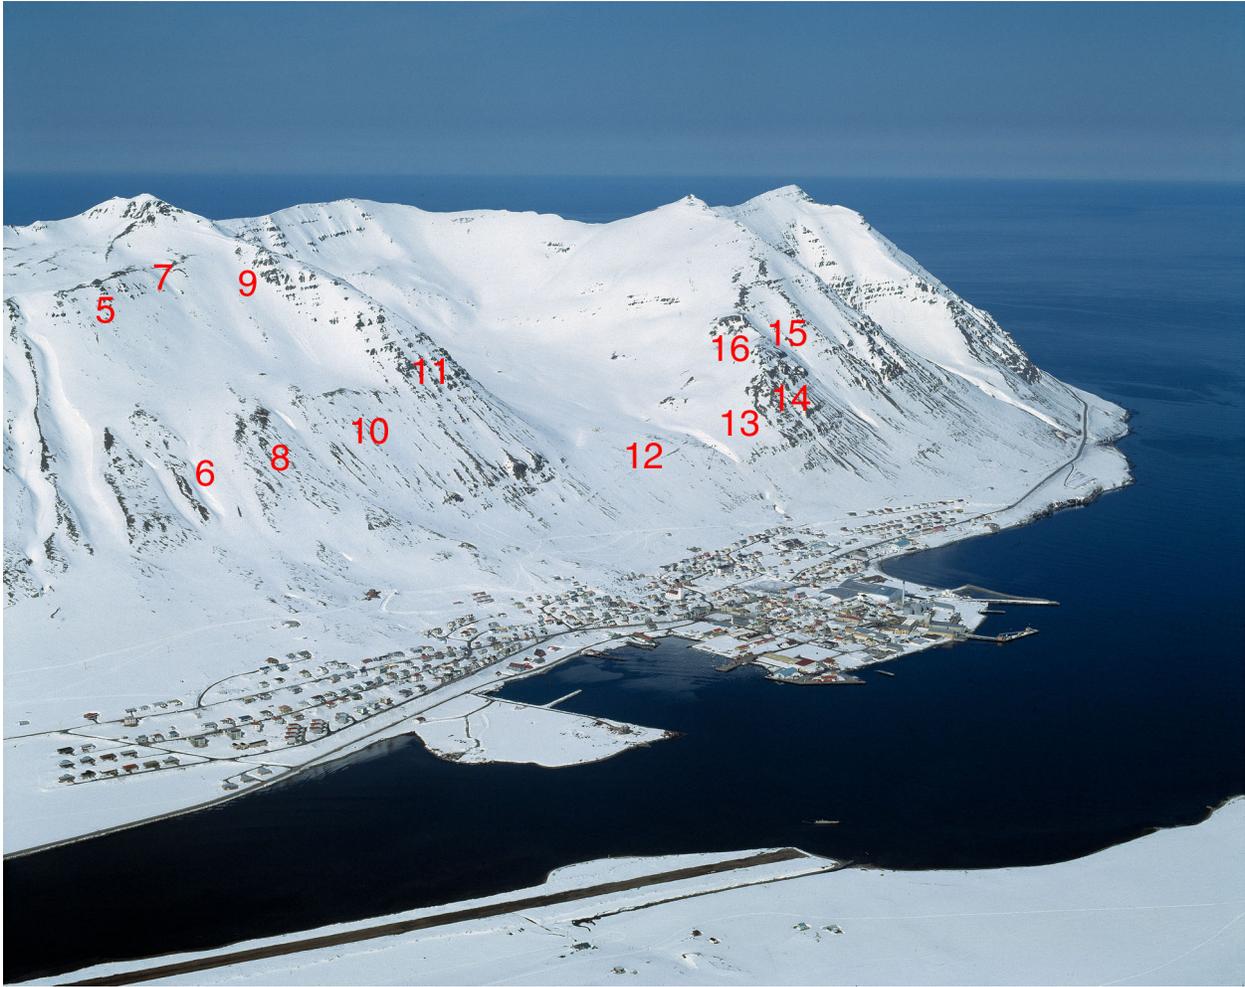
Figure 4. View from south east of the avalanche paths above Siglufjörður. The red numbers indicate the approximate location of starting areas that were delineated during field investigation (see Map 4) (Photo: Mats Wibe Lund).

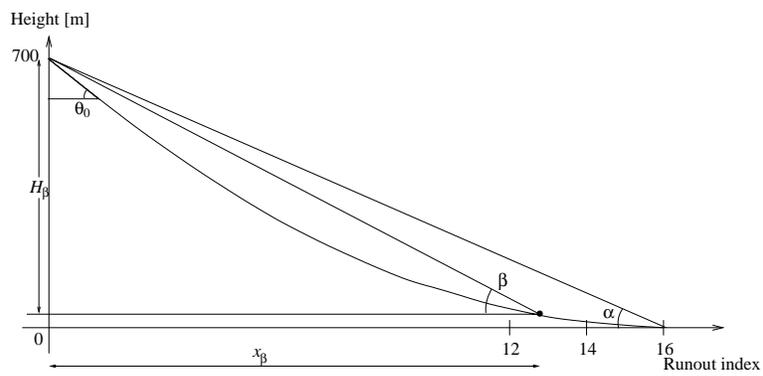
Figure 5. *The standard path. The α -angle is the expected α -angle of an avalanche according to the α/β -model.*

Runout index: The runout measured in hectometers of an avalanche that has been *transferred* (Sven Sigurðsson *et al.*, 1997) to the *standard path* making use of some transfer method. The runout index is in this report referred to as the runout index obtained by using the PCM-model with parameters lying on a predefined parameter axis. An avalanche that has a runout index of r_0 is referred to as an avalanche with $r = r_0$. The method was developed by Kristján Jónasson *et al.* (1999).

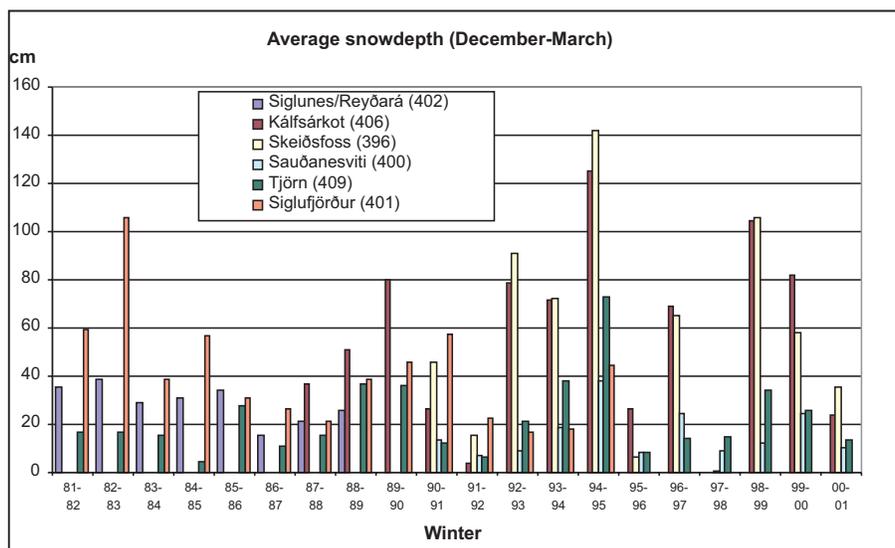
Siglufjörður, mean monthly snow depth (cm)

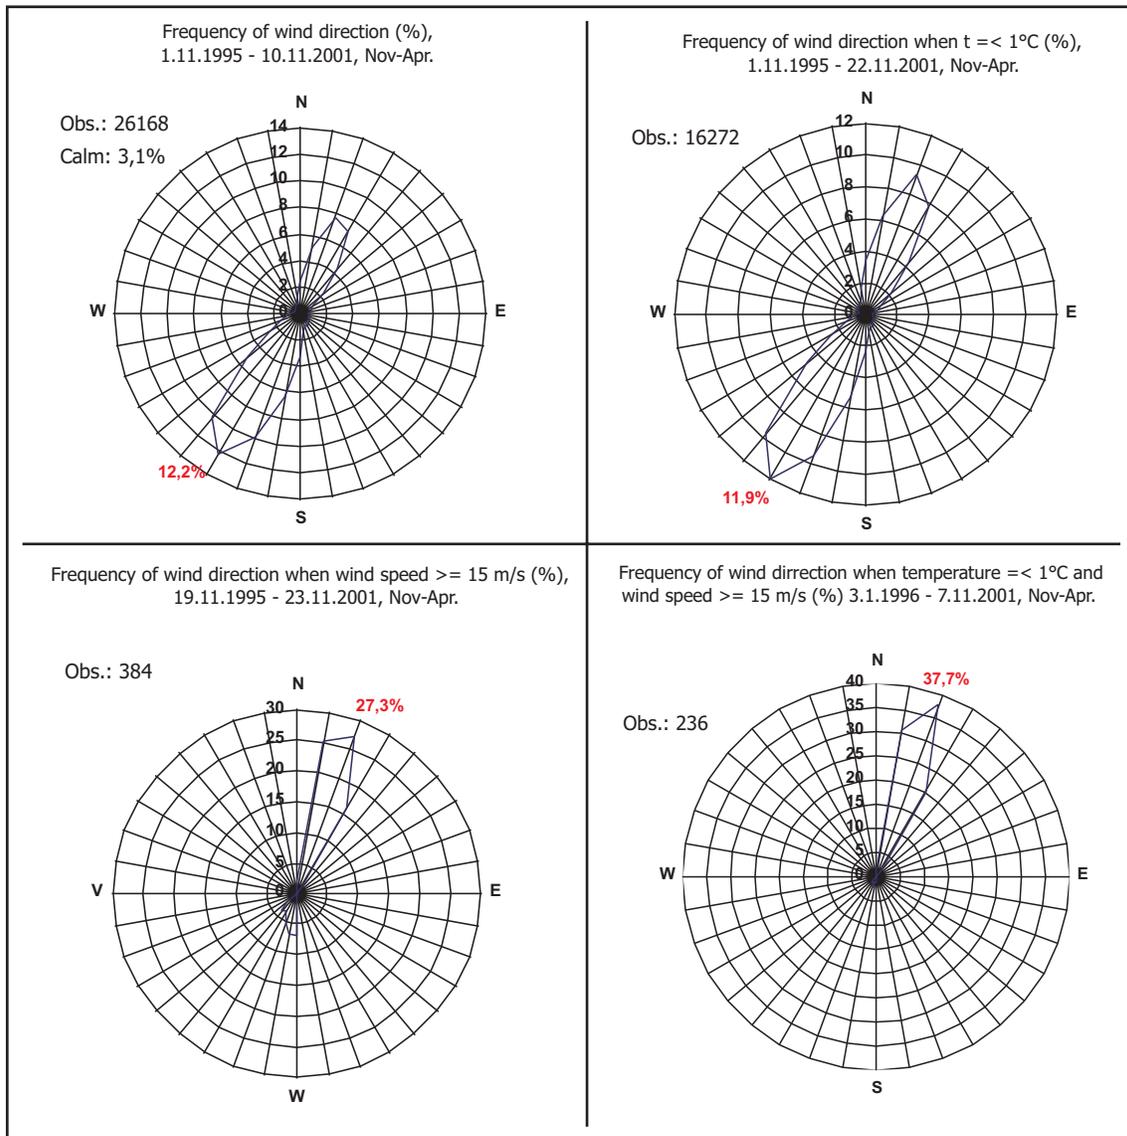
Siglufjörður, automatic weather station

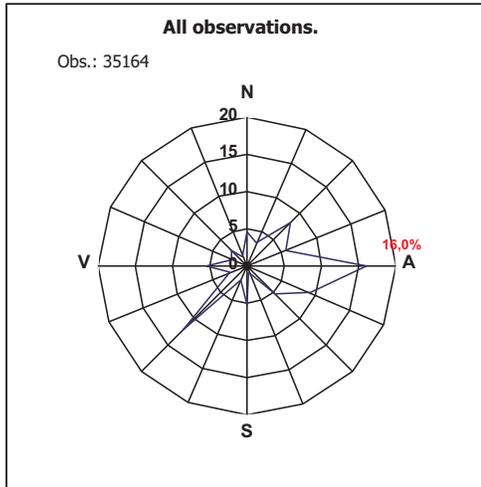
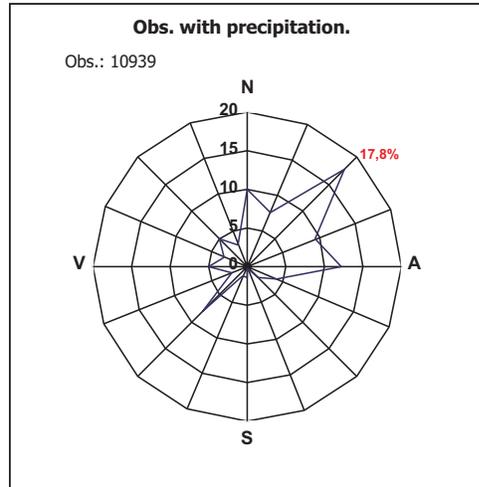
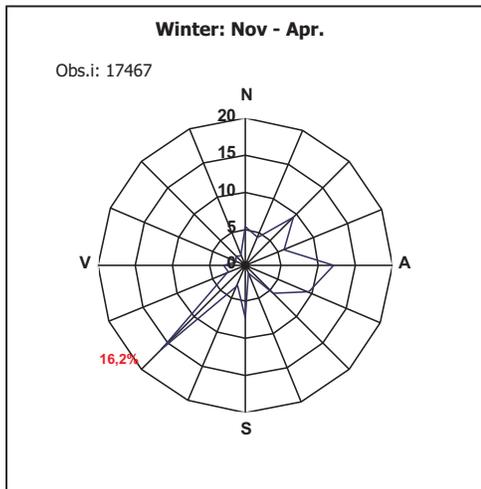
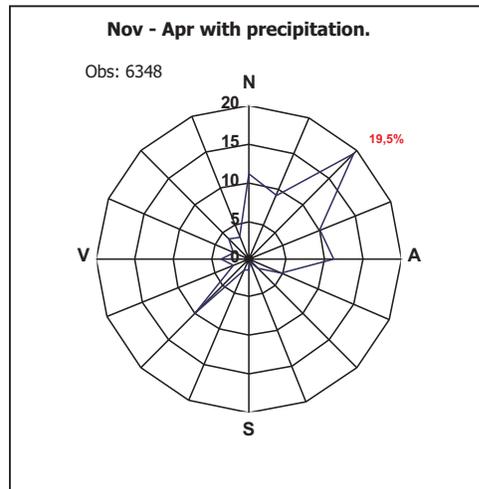
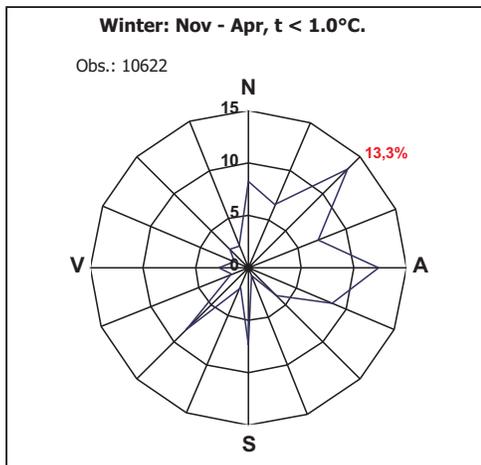
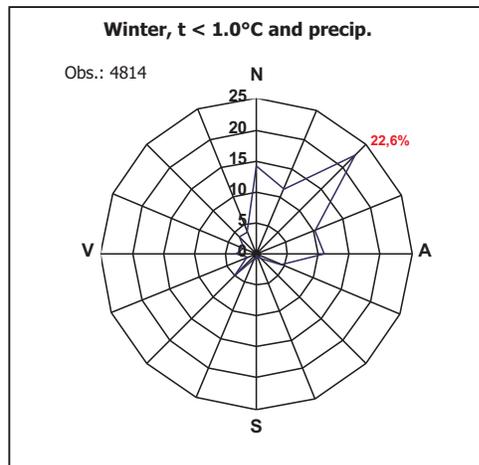
Siglunes/Reyðará, 1.1.1971–31.12.1988
