Report 03045

Report on weather conditions related to an aircraft accident 6 March 2001

Report prepared for Aircraft Accident Investigation Board

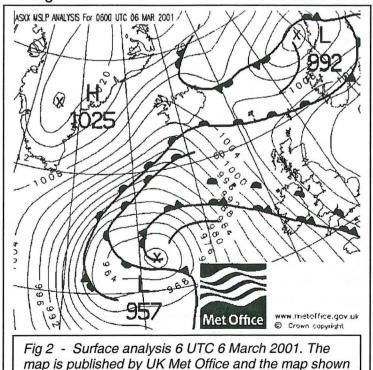
A surface analysis at 6 UTC is shown in Fig 2. The main features are a high pressure area, 1025 hPa, over Greenland and an extensive 957 hPa low some 1300 km SSW of Iceland. To the west of The British Isles there was a strong advection of warm air towards Iceland. A warm front was generated

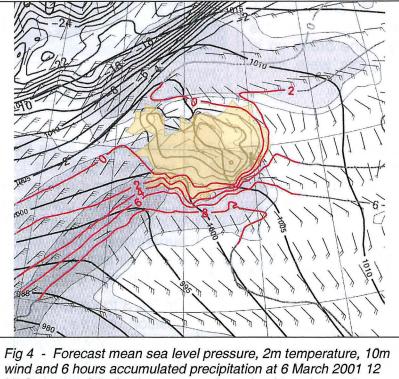
wind and 6 hours accumulated precipitation at 6 March 2001 12 UTC. A part of the isotherms are coloured red to enhance the marked warm front off SW-Iceland and the warm advection.

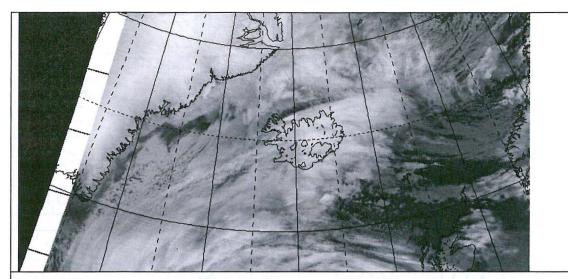
Low resolution satellite images showing the cloud cover near Iceland this morning are available and are shown in Fig 5 and Fig 6. The first one was taken at approximately 7:04 UTC and the second one at 8:41 UTC, very close to the time of the accident. Comparing these two images gives the feeling that the cloud cover off SW-Iceland has grown thicker from the time of the first image to the second one. An area of thicker clouds, corresponding to the area of strongest temperature gradient and most accumulated precipitation according to the numerical forecast shown in Fig 4, has built up. It is reasonable to guess that within this area, where the warm air was ascending over the frontal surface, the cloud deck has been rather solid and without dry layers inbetween.

Fig 5 - Infrared satellite image (NOAA14, low resolution) 6 March 2001 7:04 UTC

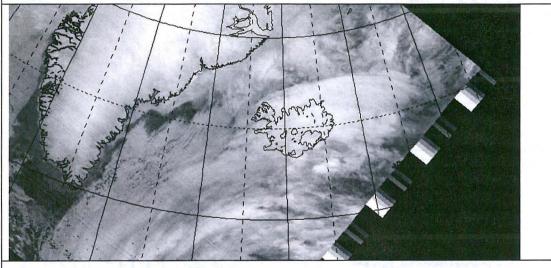
Fig 6 - Infrared satellite image (NOAA14, low resolution) 6 March 2001 8:41 UTC

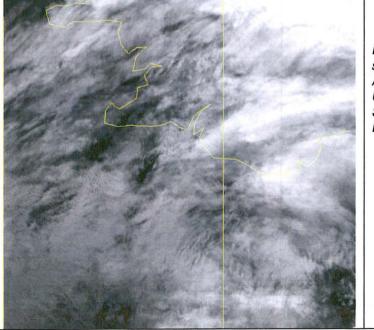
Fig 7 - High resolution infrared satellite image (NOAA14, AVHRR) 6 March 2001 7:04 UTC. Courtesy of Dundee Satellite Receiving Station, Dundee University, Scotland.

The resolution of these images (APT, 4 km resolution) is not high enough to distinguish clearly any mesoscale features with in the warm front shield. In Fig 7 a high resolution image (AVHRR, 1.1 km resolution) from the first of the two passes is shown. This image was provided by Dundee Satellite Receiving Station in Scotland. AVHRR-images from the latter pass were not available there. On this image the cloud cover does not seem to be very uniform but rather built up of mesoscale bands of thick clouds with thinner clouds inbetween.

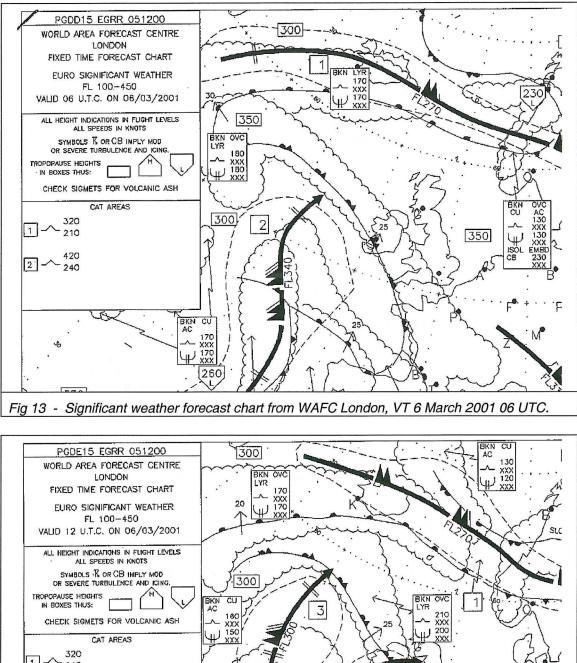
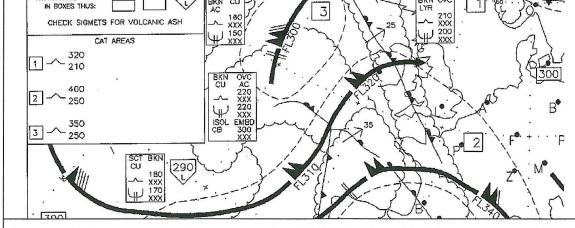
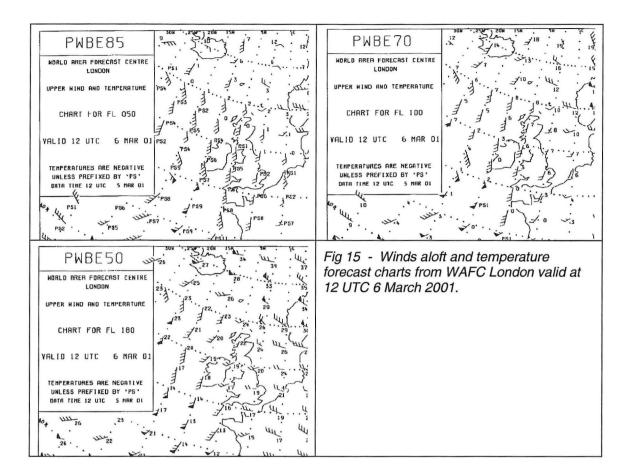
Some of the forecast charts of winds and temperature aloft and significant weather available at departure are shown in Fig 13-15.
