Esther Jensen
Thomas Sönser

Process orientated landslide hazard assessment for Eskifjörður

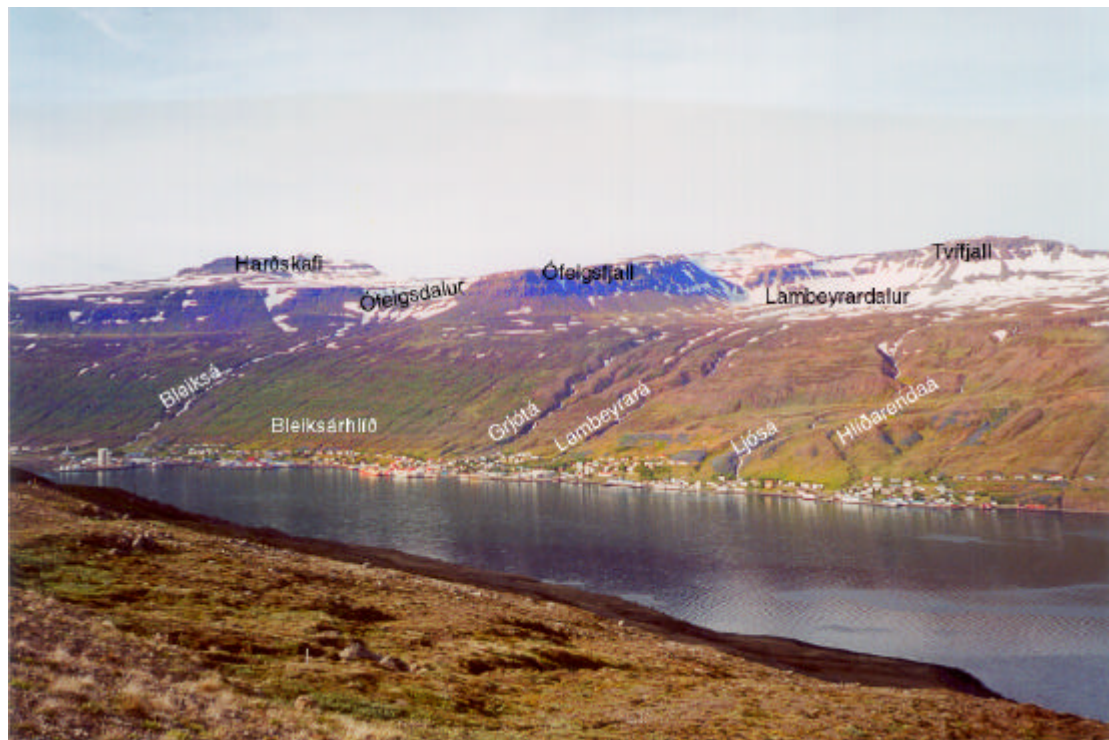
Figure 2.2 The names of the main landscape features Eskifjörður

There is a shelf at 4-600m a.s.l. in the mountain that forms a small valley above the village. This shelf narrows towards the bottom of the fjord where it disappears. Above the shelf are two cirque valleys, Ófeigsdalur and Lambeyrardalur. Inside the main valley, the slope is even up to 600 m elevation. Many streams fall down the hillside above the village. Most of them are small but five run in well defined gullies

through the village. These rivers are called (the innermost first), Bleiksá, Grjótá, Lambeyrará, Ljósá, and Hlíðarendaá.
